1992
Michigan Coastal Management Program
Final Report
8/1/93
Alva Bradley Shipwreck Site Documentation
and
Preliminary Cultural Resource Analysis

Submitted by
Glen Arbor Township
and
Manitou Underwater Preserve Committee
of the
Northwest Michigan Maritime Museum

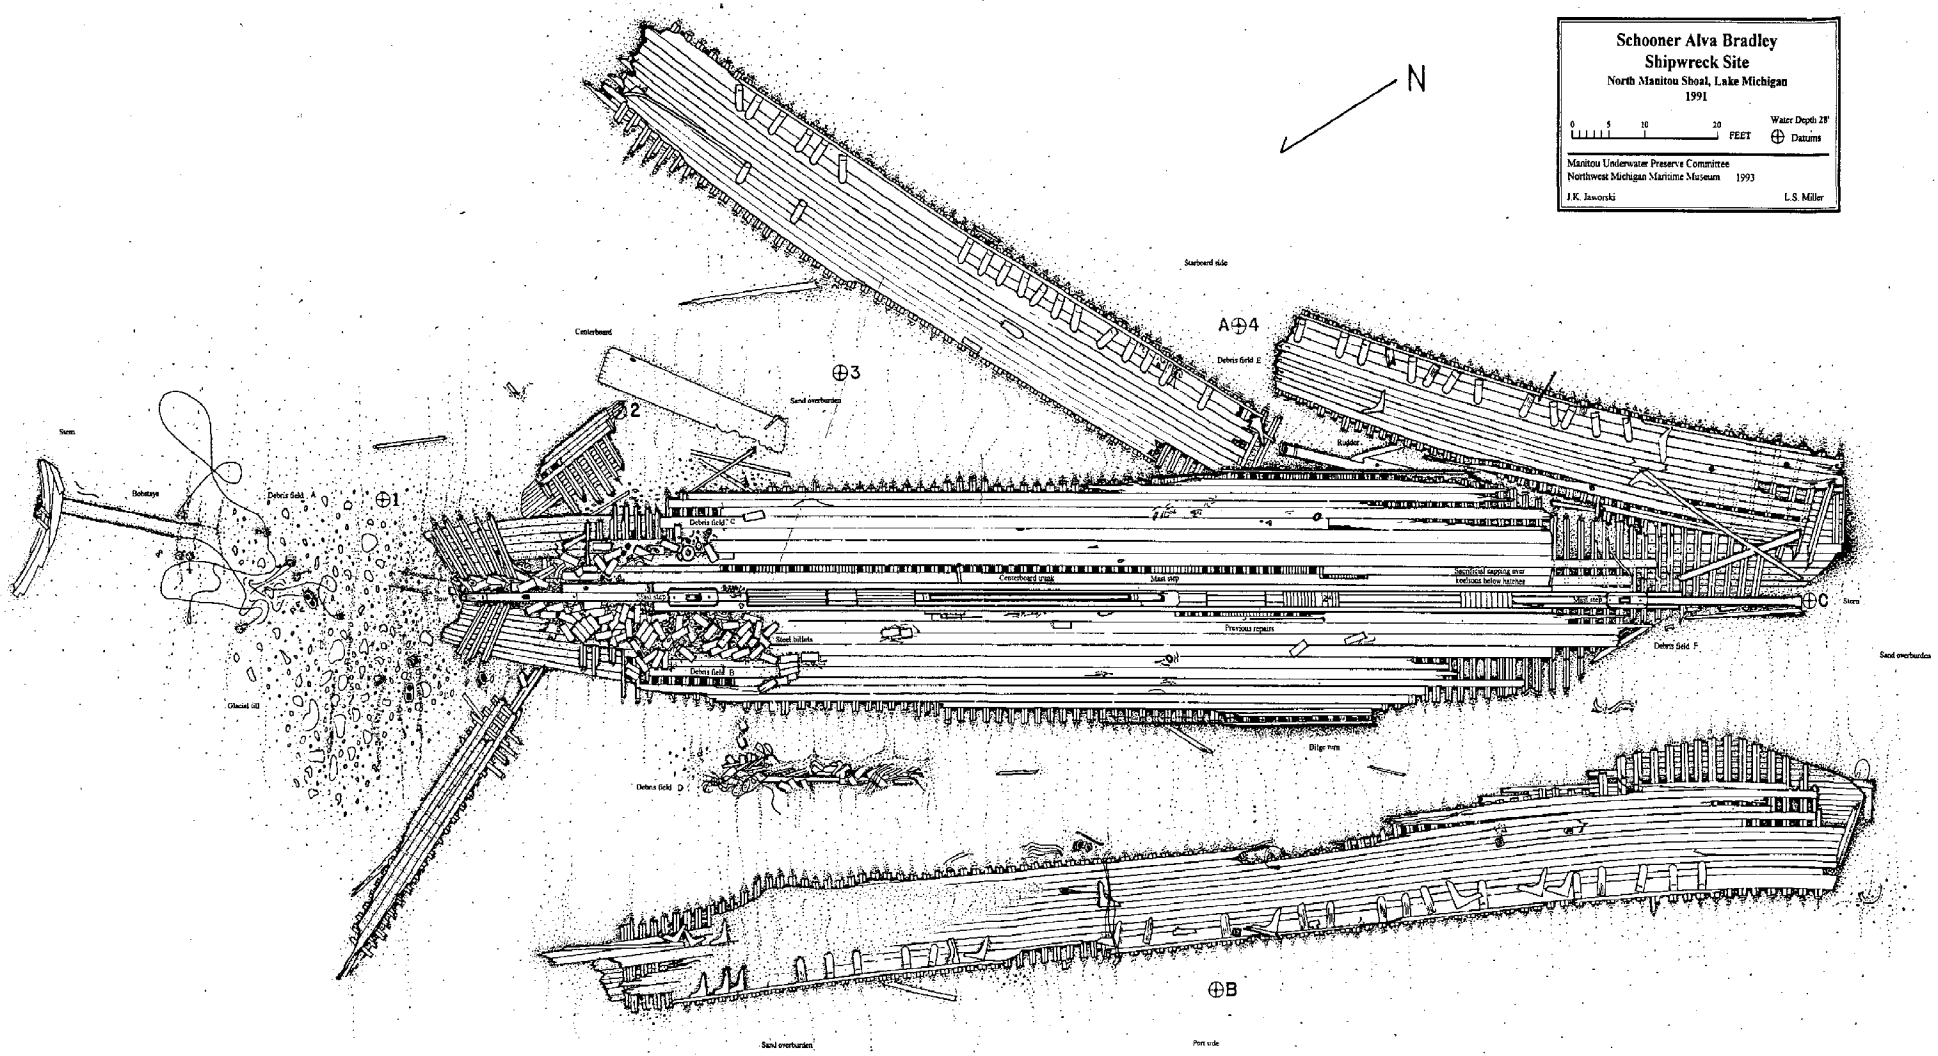
Schooner Alva Bradley
Shipwreck Site
North Manitou Shoal, Lake Michigan
1991
0 5 10 20 FEET
Water Depth 28'
Datums
Manitou Underwater Preserve Committee
Northwest Michigan Maritime Museum 1993
J.K. Jaworski
L.S. Miller
N
Starboard side
Centerboard
A
4
3
2
1
B
C
Debris field E
Debris field C
Debris field A
Debris field B
Debris field D
Debris field F
Sand overburden
Stem
Bobstaye
Rudder
Centerboard trunk
Mast step
Steel billets
Previous repairs
Bilge run
Glacial till
Port side
