SUBMERGED HISTORICAL RESOURCES OF PENSACOLA BAY, FLORIDA PHASE TWO

Submerged Cultural Resource Management Report

Contract CM-320
Year One

Florida Bureau of Archaeological Research
Division of Historical Resources
Florida Department of State
Jim Smith, Secretary of State

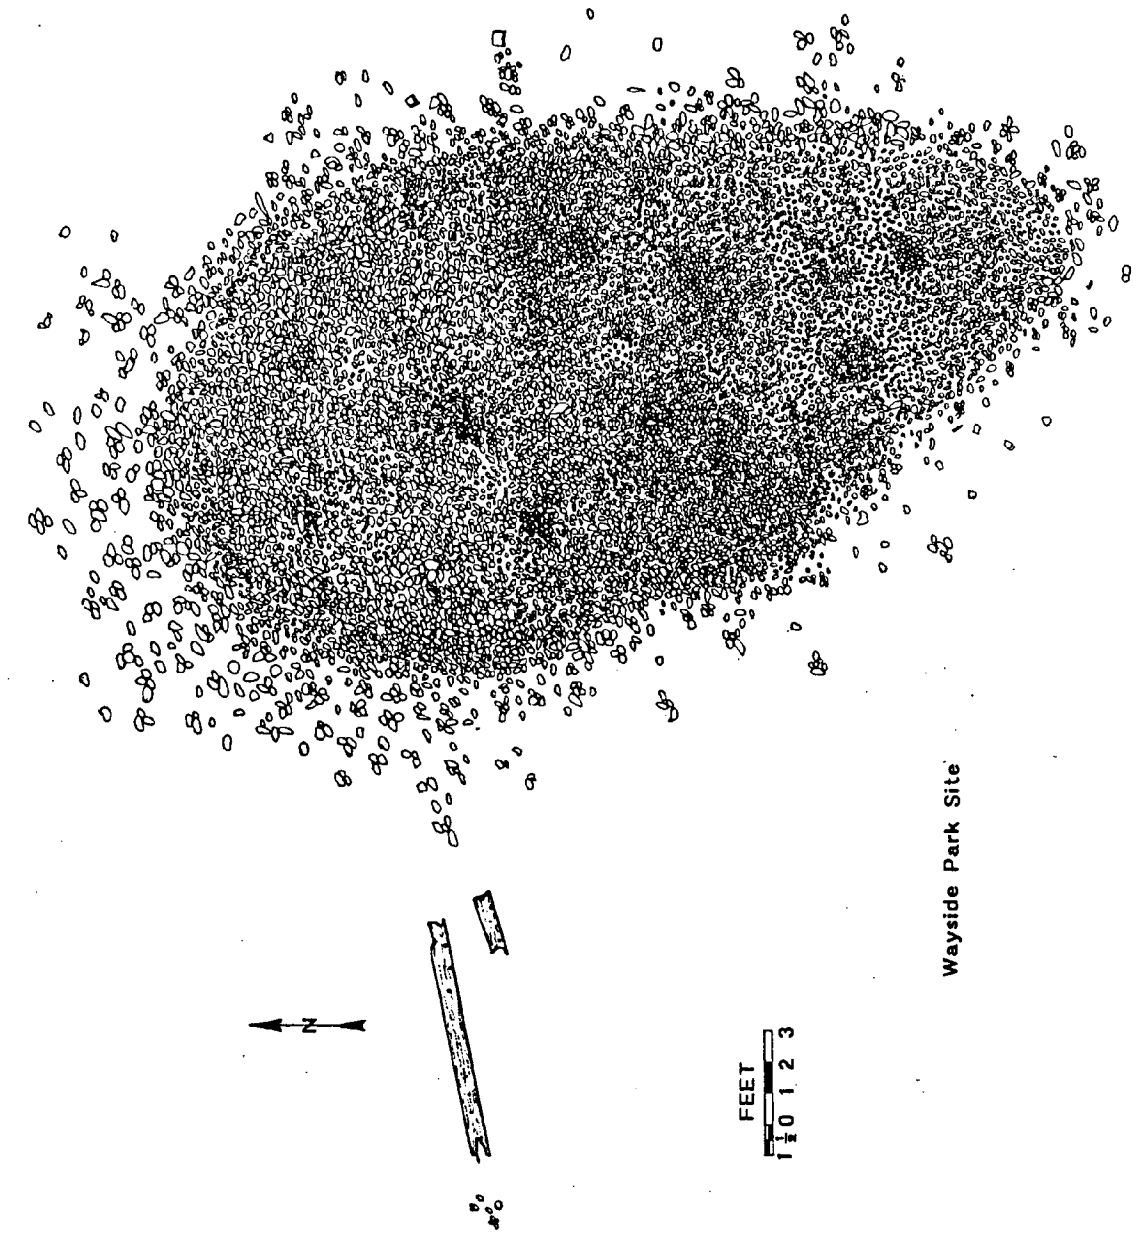
Figure 17. Site Plan of Wayside Park Site.

The site consists of a large stone ballast pile and exposed ship timbers. For the purposes of recording, the baseline was run along the longitudinal axis of the vessel east to west. No excavations

were conducted and all elements were drawn in place. The largest concentration of ballast extends 30 feet to the north and 50 feet to the east. The ballast slopes northward from 10 feet to 22 feet in depth. The ballast is hand size river cobble mostly uniform in size and is not indigenous to Pensacola.
